**INDEPENDENT
ENVIRONMENTAL AUDIT
REPORT**

Western Sydney University – Bankstown, 74
Rickard Road, Bankstown NSW

Walker Corporation Pty Ltd
20 December 2022

21068 R5

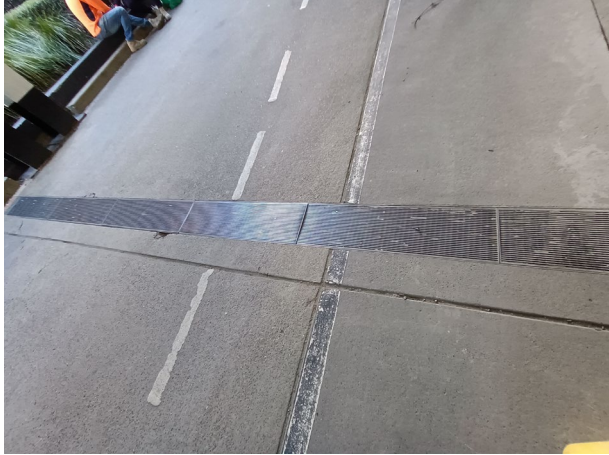
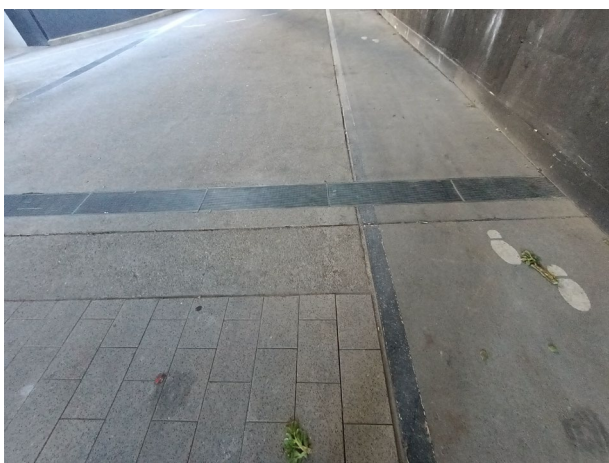
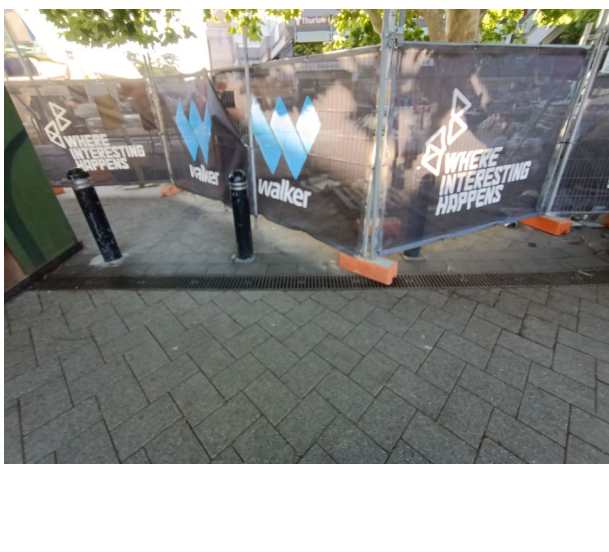
<p>Geosyntec Ref.: Z57, Z101, Z170</p>	<p>Date: 15/11/2022</p>

A photograph showing a stormwater drain on a paved road. The drain is a long, narrow, rectangular metal grate set into a concrete curb. The road surface is asphalt with white dashed lines. In the background, a person is visible sitting on a bench.
<p>Description:</p> <p>No geotextile observed in the stormwater drains west of the site, but no evidence of sediment and silt was observed. No other stormwater drains observed.</p>

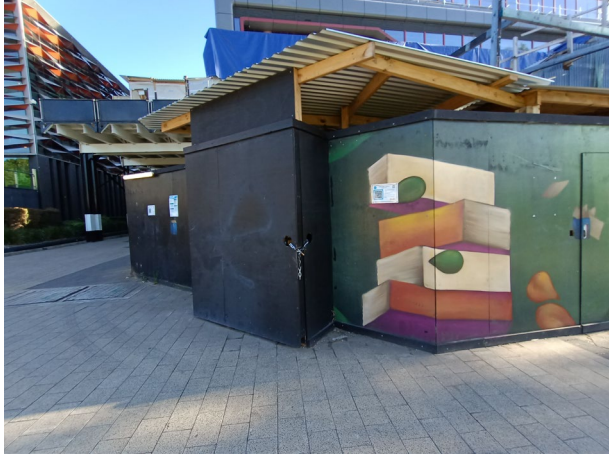
<p>Geosyntec Ref.: Z88, Z89, Z108, Z147, Z148, Z151</p>	<p>Date: 15/11/2022</p>

<p>Description:</p> <p>Hoarding across the boundary showing no evidence of third-party advertising.</p> <p>Public way was not obstructed with materials, vehicles, refuse, skips associated with construction work.</p>

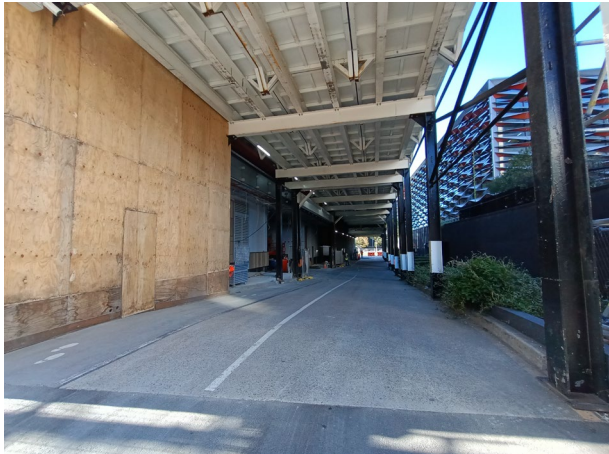
<p>Geosyntec Ref.: Z100</p>	<p>Date: 15/11/2022</p>	 
<p>Description:</p> <p>No dust observed, building has been constructed.</p>

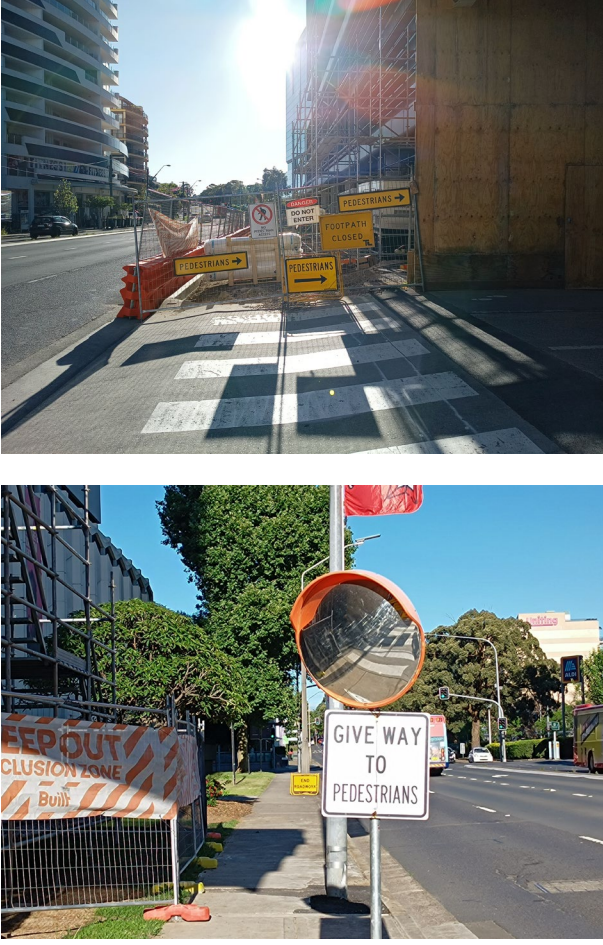
<p>Geosyntec Ref.: Z178, Z200</p>	<p>Date: 15/11/2022</p>

<p>Description: Pedestrian refuge and signage constructed in the shared vehicle zone along Rickard Rd</p>

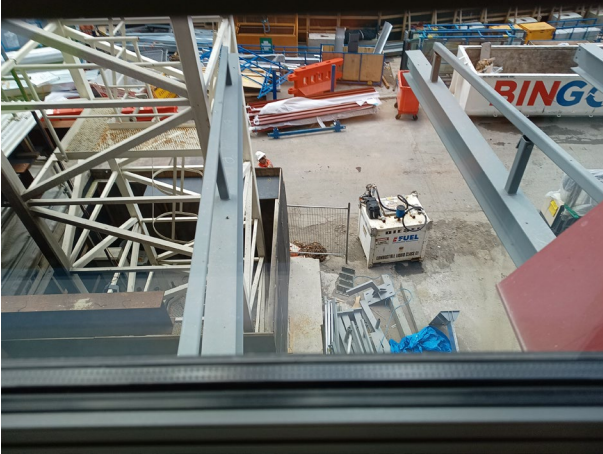
Geosyntec Ref.: Z110, Z209, Z212	Date: 15/11/2022

Description: Diesel fuel for crane generator in a self-bunded container.
