# **INDEPENDENT ENVIRONMENTAL AUDIT REPORT**

Western Sydney University – Bankstown, 74 Rickard  
Road, Bankstown NSW

Walker Corporation Pty Ltd  
23 July 2021  
21068 R2

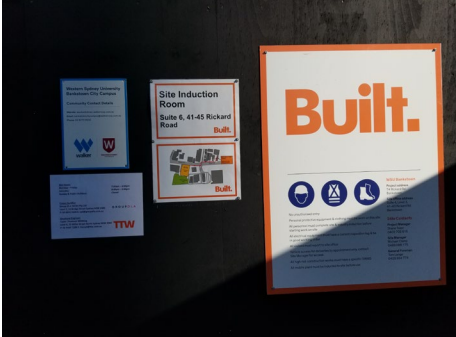
<p>Zoic Ref.:  Z79, Z142, Z146, Z185</p>	<p>Date:  9/6/2021</p>

<p>Description:  Site notice showing contact details</p>

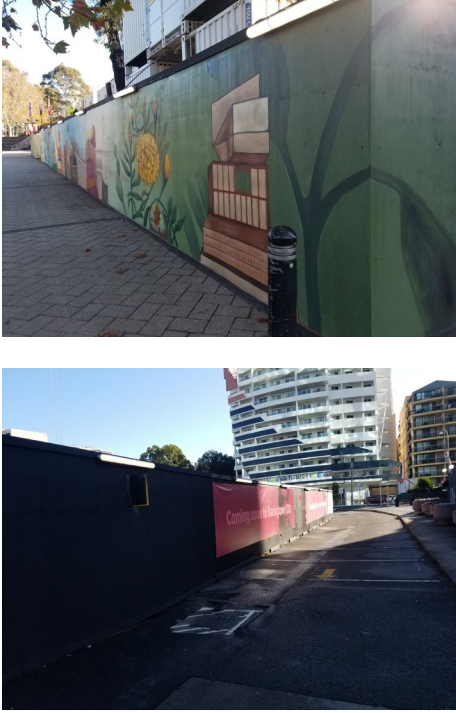
<p>Zoic Ref.:  Z88, Z89, Z108, Z147, Z148</p>	<p>Date:  9/6/2021</p>

<p>Description:  Hoarding across the boundary showing no evidence of third-party advertising.  Public way was not obstructed with materials, vehicles, refuse, skips associated with construction work.</p>

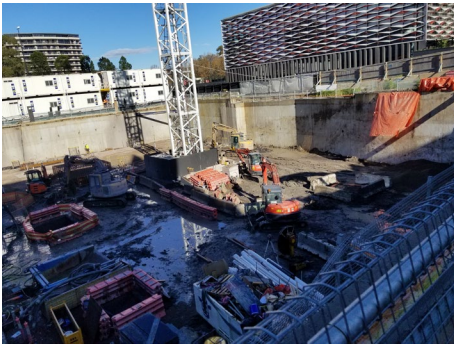
<p>Zoic Ref.: Z100</p>	<p>Date: 9/6/2021</p>

<p>Description: Excavation wall has been stabilised.</p>

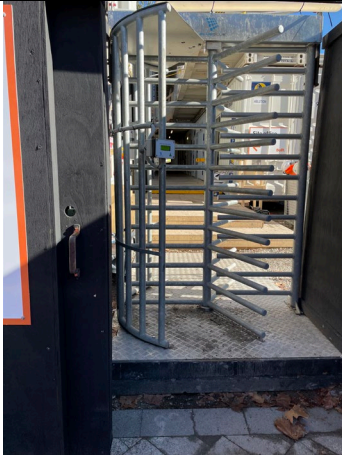
<p>Zoic Ref.: Z148</p>	<p>Date: 9/6/2021</p>

<p>Description: Turnstile at site entrance</p>

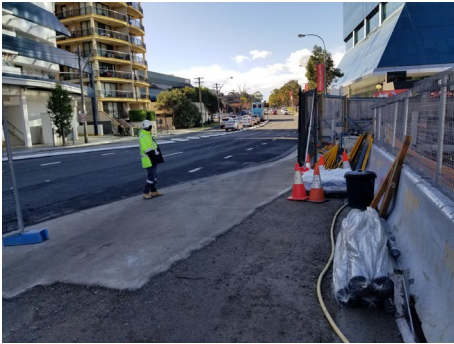
<p>Zoic Ref.: Z148, Z172, Z174, Z177</p>	<p>Date: 9/6/2021</p>

<p>Description: Chain mesh fencing present along Rickard Road.  Traffic controller was observed.</p>
