**INDEPENDENT
ENVIRONMENTAL AUDIT
REPORT**

74 Rickard Road, Bankstown NSW 2200

Walker Corporation Pty Ltd
8 December 2023

AU123160 R1

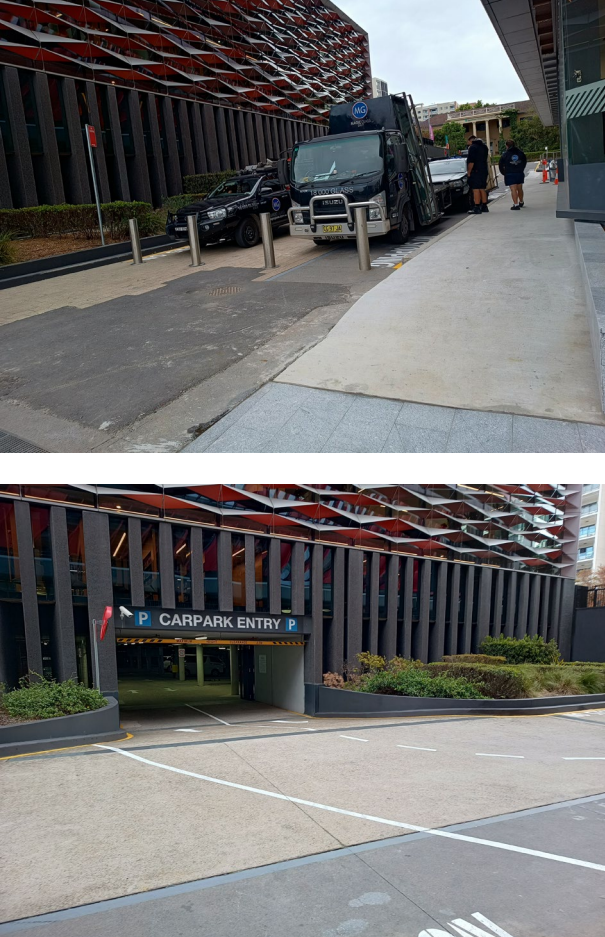
Photo Number: G153	Date: 17/10/2023

Description: Line and marking on BLaKC Drive.

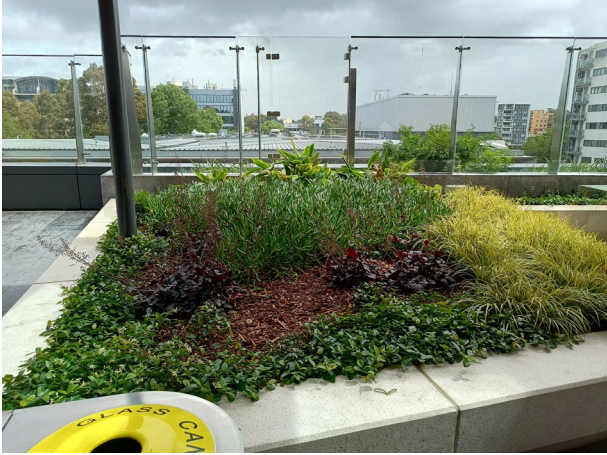
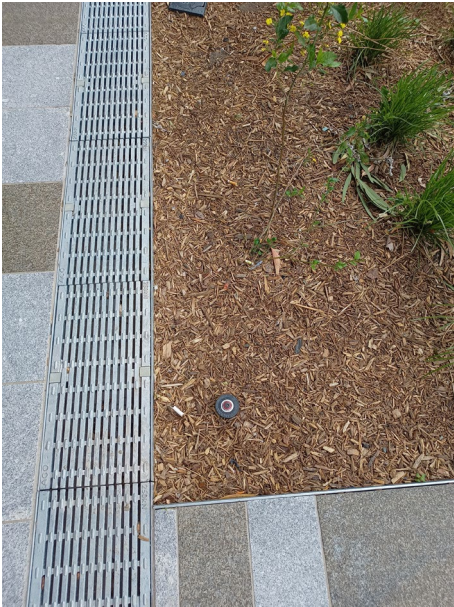
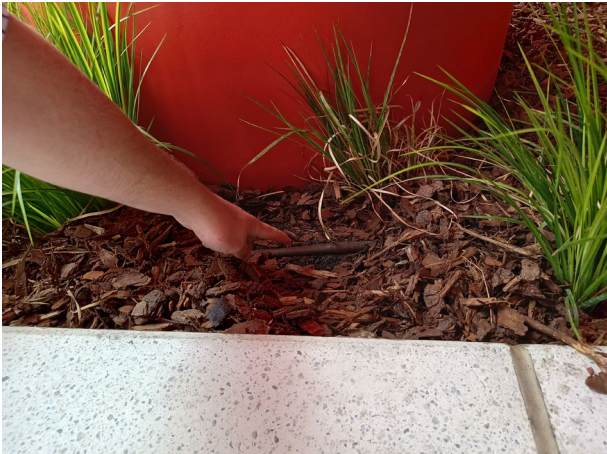
<p>Photo Number: G155, G174, G235</p>	<p>Date: 17/10/2023</p>

<p>Description: Landscaping was observed to be completed and in good condition. Irrigation was observed.</p>

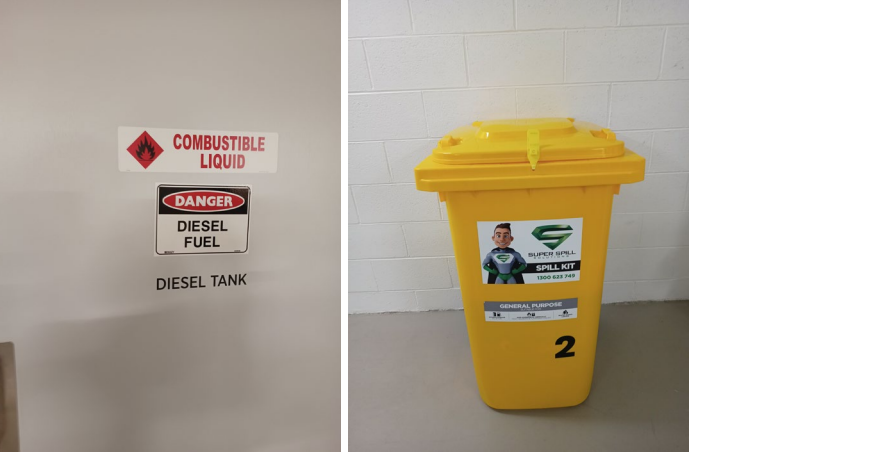
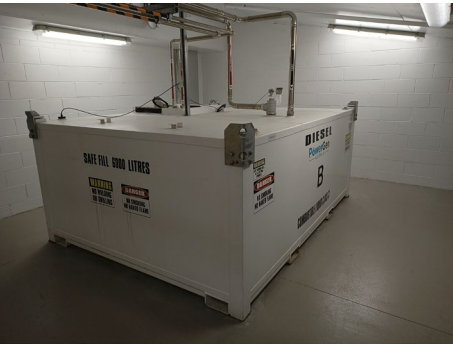
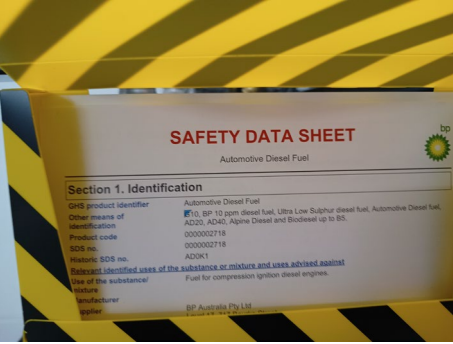
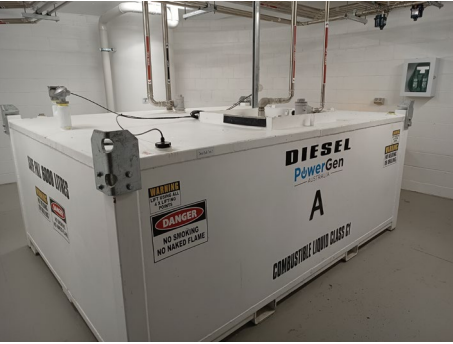
<p>Photo Number: G176</p>	<p>Date: 17/10/2023</p>

<p>Description: Diesel tanks in Basement Level 2.</p>

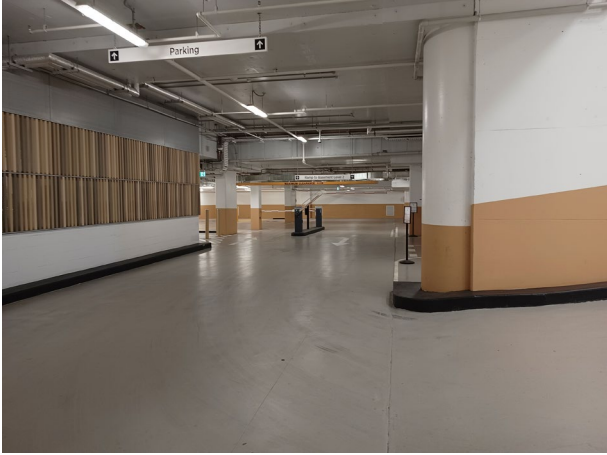
Photo Number: G205	Date: 17/10/2023

Description: Secured parking with boom gate observed.

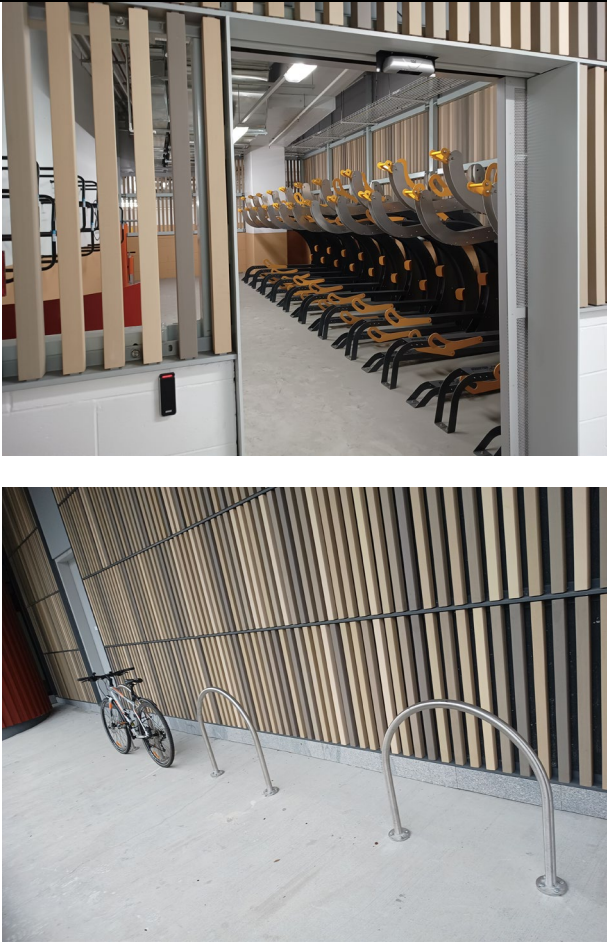
Photo Number: G206	Date: 17/10/2023

Description: Bicycle spaces around the campus.

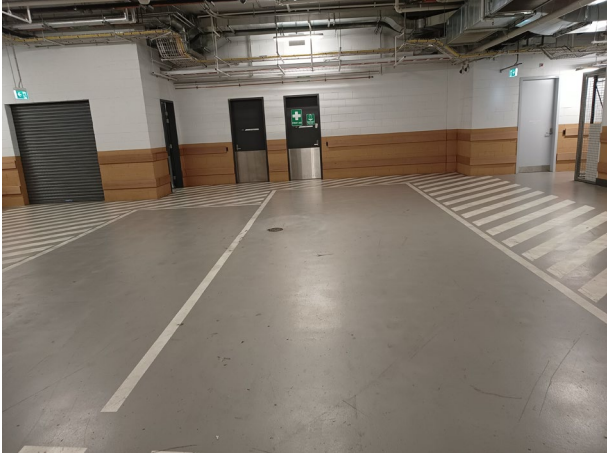
Photo Number: G208	Date: 17/10/2023

Description: A loading dock to fit one medium rigid vehicle and one small rigid vehicle were observed on Level 1.

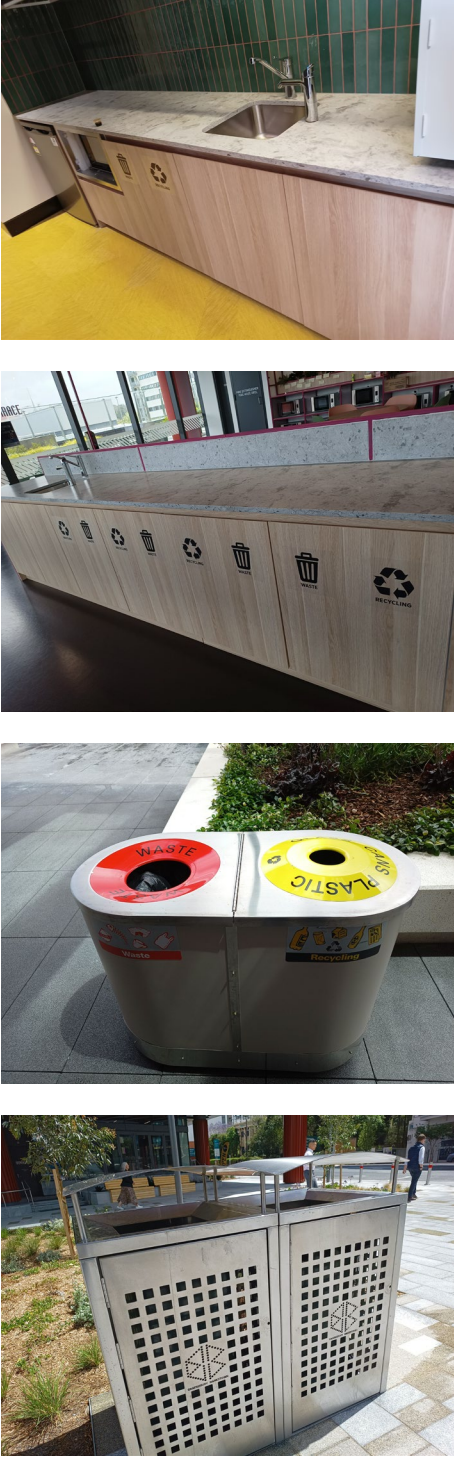
<p>Photo Number: G224</p>	<p>Date: 17/10/2023</p>

<p>Description:</p> <p>Bins (general waste and recycling) were observed in high traffic areas, food preparation areas and in public domain.</p>

Waste	To re-use, recycle and dispose of waste.	<ul style="list-style-type: none"> Operational Waste Management Plan was prepared to manage operational waste handling, storage and disposal. During the site audit, three different types of bins (red, yellow, and blue) were observed on site bin room. According to information provided by Walker, the site is in the process of providing: <ul style="list-style-type: none"> Green bins which is for organic waste. Geosyntec noted that there is a condition in the site Operational Waste Management Plan that "Green waste generated from landscaped areas of the building will be removed by the designated maintenance contractor during maintenance of landscaped areas." Regular collection of e-waste stream. General waste and recycling bins were observed in high traffic areas, food preparation areas, and in restrooms. During the site audit, the bins located in the Basement 1 bin room were observed to contain the appropriate waste that they were intended for. Waste room floor was sealed, flat and even. Electrical outlet was observed at height. Adequate lighting, space and access were provided. Taps and grated drain were also observed. Insert info on imaging consumables, bulky waste, and disposal records etc (see G229, 230, 231) Sanitary bins were also observed in the bathrooms. Ventilation in waste room was certified by Climatech on 11 January 2023. According to the certificate, the mechanical air handling system was installed in accordance with the design and specification in AS1668.2.

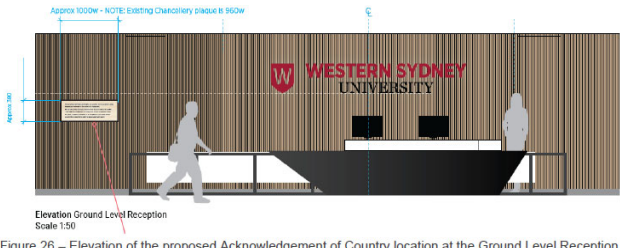
<p>Figure 26 – Elevation of the proposed Acknowledgement of Country location at the Ground Level Reception</p>	<p>17/10/2023: Observation: - Acknowledgement of Country was observed at the Ground Level Reception area.</p>

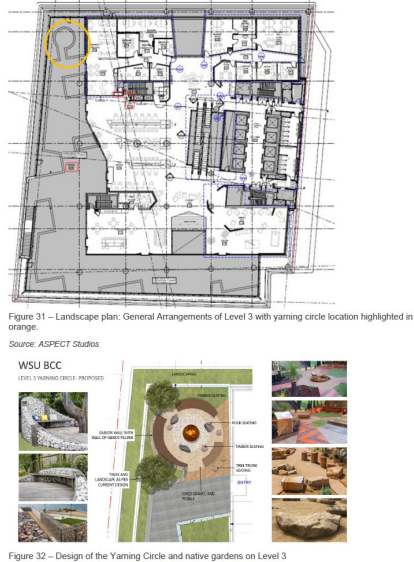
<p>Figure 31 – Landscape plan: General Arrangements of Level 3 with yarning circle location highlighted in orange. Source: ASPECT Studios</p> <p>WSU BCC LEVEL 3 YARNING CIRCLE: PROPOSED</p> <p>Figure 32 – Design of the Yarning Circle and native gardens on Level 3</p>	<p>17/10/2023: Observation: - Yarning Circle observed in Level 3.</p>					
G214	Heritage Interpretation Plan	4.7.3	<p>The concept of 'earth, sun and skin' was also raised during consultation with the RAPs for preparation of this HIP and can be reflected in the colour scheme and materiality of the tower itself. Partnered with the use of native plantings across the façade, the design of the WSU tower itself is a bold nod to Aboriginal culture and art.</p>	<p>17/10/2023: Observation: - The WSU tower was observed to be in accordance with the design.</p>
