**INDEPENDENT  
ENVIRONMENTAL AUDIT  
REPORT**

Western Sydney University – Bankstown, 74  
Rickard Road, Bankstown NSW

Walker Corporation Pty Ltd

21 June 2022

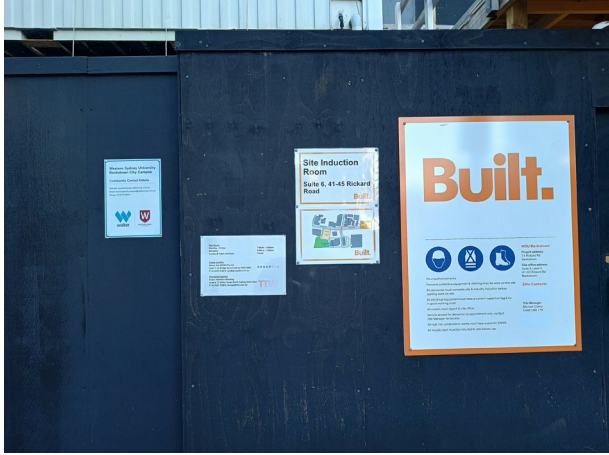
<p>Geosyntec Ref.:  Z79, Z142, Z146, Z185</p>	<p>Date:  17/05/2022</p>

<p>Description:  Site notice showing contact details</p>

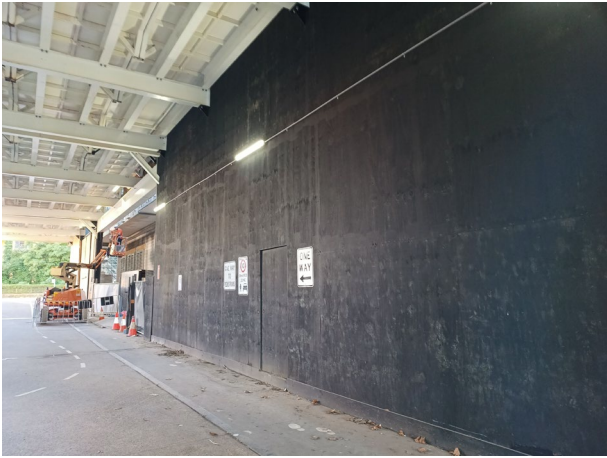
<p>Geosyntec Ref.:</p> <p>Z88, Z89, Z108, Z147, Z148, Z151</p>	<p>Date:</p> <p>17/05/2022</p>

<p>Description:</p> <p>Hoarding across the boundary showing no evidence of third-party advertising.</p> <p>Public way was not obstructed with materials, vehicles, refuse, skips associated with construction work.</p> <p>Lighting was observed under B class hoarding.</p>

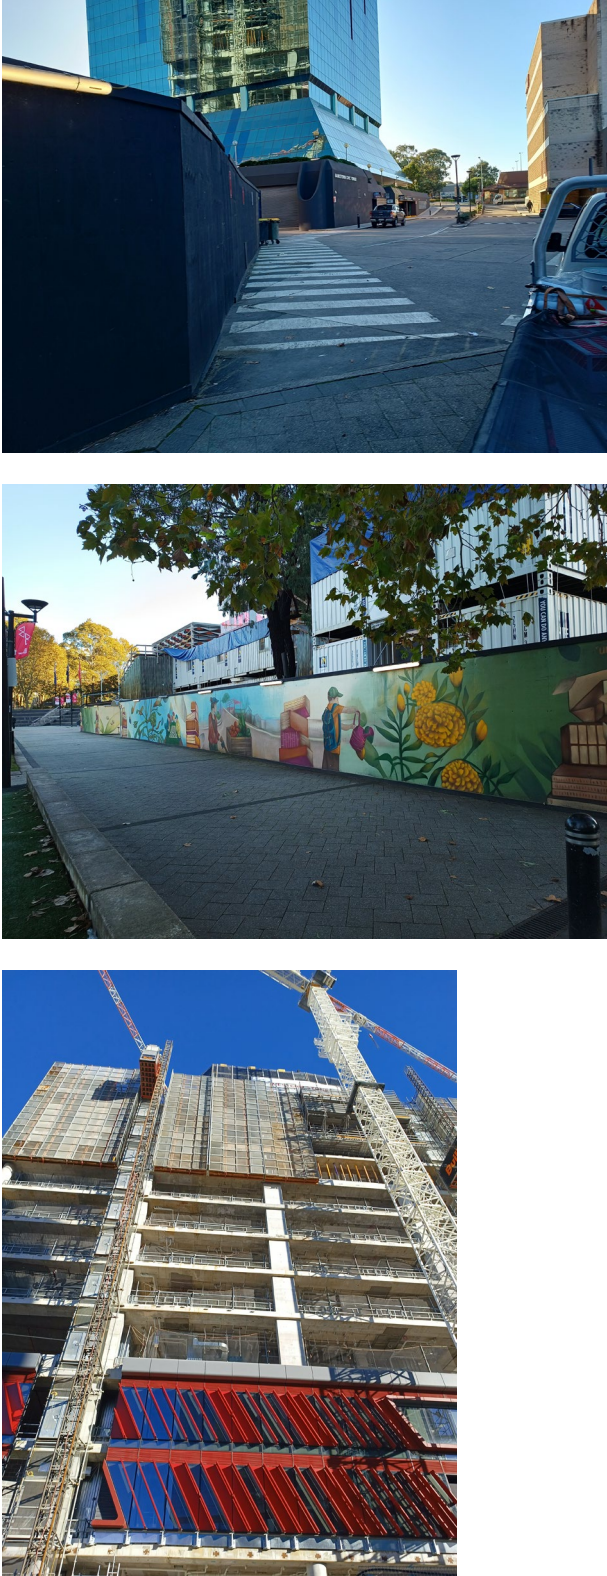
<p>Geosyntec Ref.: Z100</p>	<p>Date: 17/05/2022</p>

<p>The first photograph shows a street view with a blue building under construction in the background and a white zebra crossing in the foreground. The second photograph shows a colorful mural on a wall, featuring a person and various plants. The third photograph shows a building under construction with cranes and a red and blue facade.</p>
<p>Description:</p> <p>No dust observed, building has been constructed.</p>

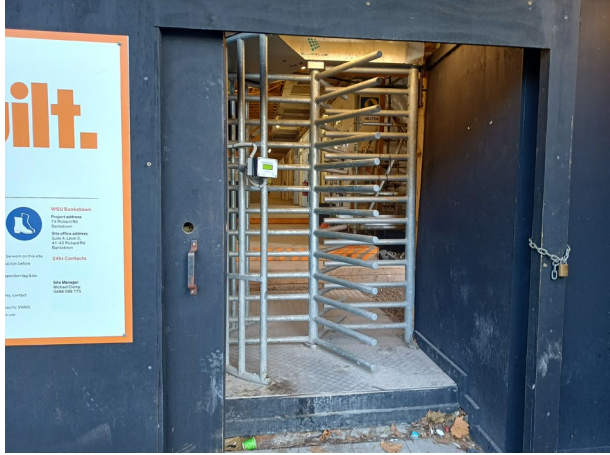
<p>Geosyntec Ref.: Z148</p>	<p>Date: 17/05/2022</p>

<p>Description: Turnstile at site entrance</p>

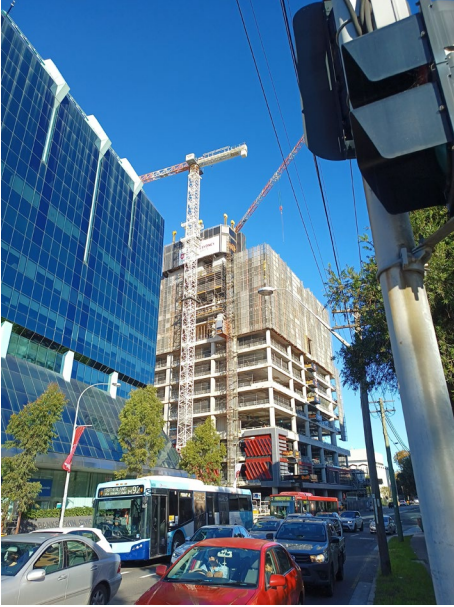
<p>Geosyntec Ref.: Z157</p>	<p>Date: 17/05/2022</p>

<p>Description: Crane was painted orange and white.</p>
